Manhole Inspection Summary

Manhole # S15GG1026MH

Insp Date: **3/1/07 9:16 AM**

Location Address: **2409 OSWEGO AVE**

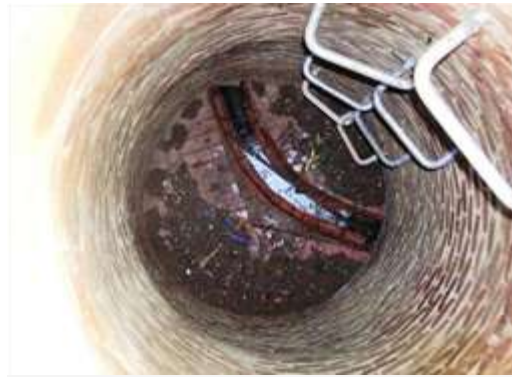
Top View

Evidence of surcharge - Bench debris.

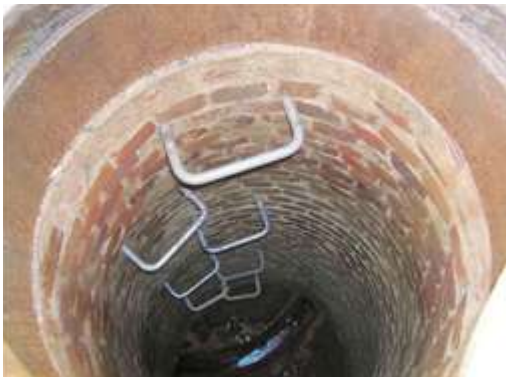
Defect

Frame leaks. Adjustment, Corbel, and Barrel infiltration.

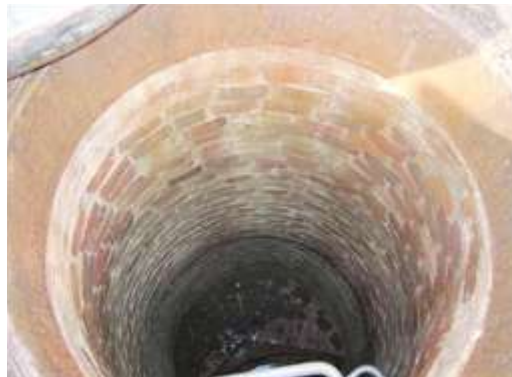
Defect

Frame leaks. Adjustment, Corbel, and Barrel infiltration - other side.

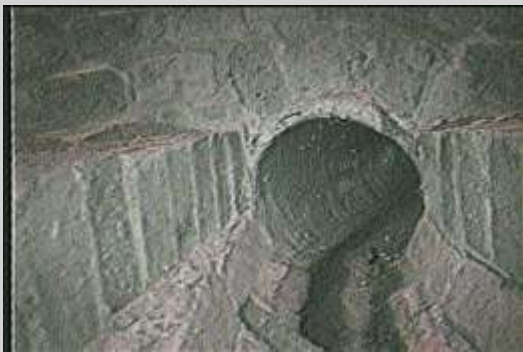
8 in. Circular Gravity Sewer Pipe Out @ 12 O'Clock

Infiltration: **Evidence** Pipe Seal Cond: **Unknown**
